INSPECTION, ASSESSMENT, AND MONITORING OF RAILROAD ARCH BRIDGES IN SOUTHWESTERN PENNSYLVANIA

Thomas E. Boothby^{*}, Kent M. Hulet[†] and Terry R. Stanton[§]

Key words: Arch, Bridges, Inspection, Assessment, Monitoring

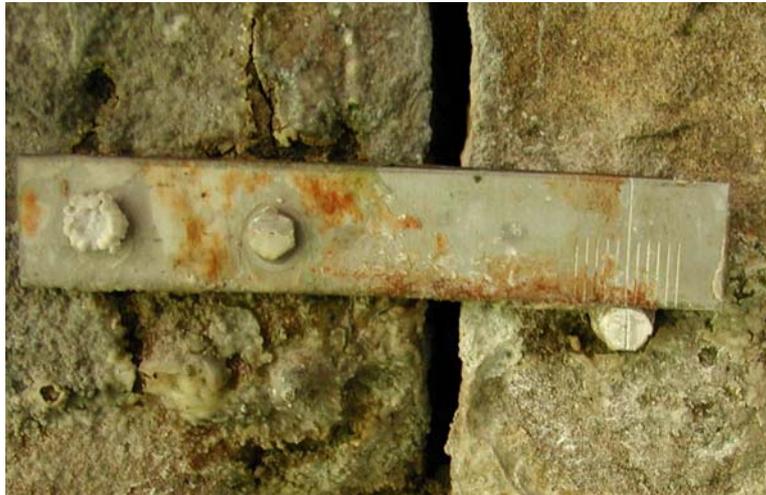
Figure 2: Crack gauge installed on bridge 1

Six crack gauges are located on bridge 1. Only 3 of the 6 were accessible by an aerial lift. Readings were obtained from gauges located on spans 1 and 2. Of the inspected gauges, 2 had not moved from on center and the third was judged to be off by approximately 1mm.

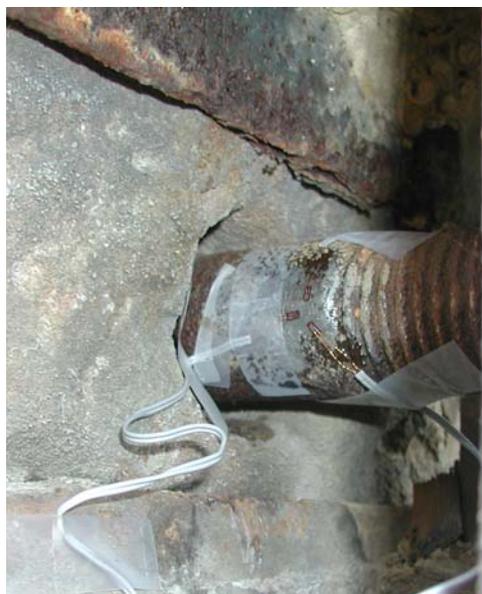
Figure 3: Strain gauges applied to tie-rod

Damage sustained by the 135° gauge during the experiment caused it to give a reading of 0 from the second reading on. Due to this event, actual stress values cannot be calculated. However, the data collected were sufficient to prove the presence of residual stresses in the rod.

Since there are residual stresses in the rod, it is evident that tilt in the spandrel walls is creating a transverse load that is pushing against the steel tie-rod reinforcing system. The strain gauge test validates surveying results that showed that the spandrel walls are leaning out.

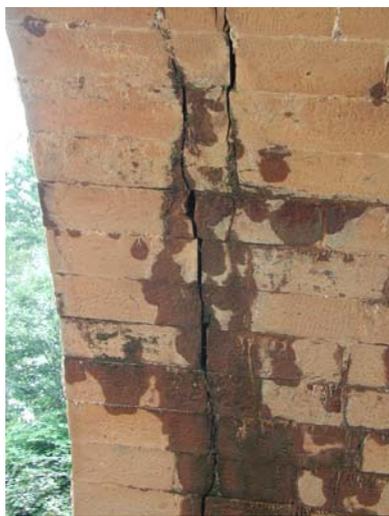
Figure 4: Bridge 3

Three main patterns were seen while inspecting the arch barrels of the bridges. The first and most apparent is that on a majority of the spans, cracks run at a distance approximately one block length inwards from the edge of the wall. This corresponds to the approximate thickness of the spandrel wall of the bridges. A probable cause for cracks in these locations is a separation of the spandrel wall from the arch barrel. Examples are provided in figures 4 and 5 to show this common cracking pattern.

Spandrel walls are leaning out as a result of transverse pressures. This can explain the presence of cracking at the first mortar joint in from the arch barrel edge. The spandrel walls are separating from the arch barrel, causing cracks to form.

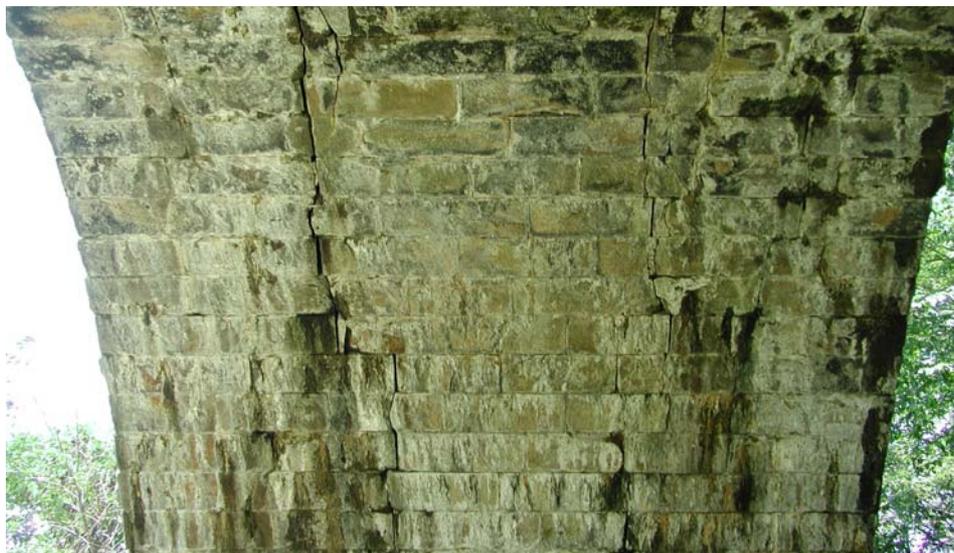
Figure 6: Bridge 1, span 2

The third crack pattern occurs at the midpoint of the arch barrel where transverse bending moments are generally maximum. This pattern is shown in figure 6. Cracking in the middle of the arch barrel is common in masonry bridges during their life span and is shown in figure 7.

Cracks in the arch barrel most likely formed as a result of railroad loading. A majority of these cracks have not grown since the bridges have been removed from rail service. Due to these longitudinal cracks, water drainage carries fill with it and causes the formation of sinkholes on the gravel bridge decks.

The implementation of a drainage scheme for all bridges is necessary to prevent further deterioration.

Sink holes in the road bed of any of the bridges should be refilled and repaired immediately to account for fill loss through arch barrel cracks.

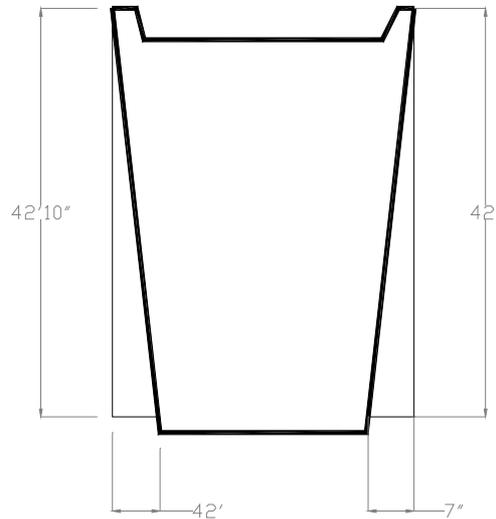
Plumb bob measurements offered a rough estimation that the spandrel walls were tilting outward at angles of 1.5° and 3° on the upstream and downstream sides, respectively. The

outward tilt of the spandrel walls were confirmed by using a total station to sight along the vertical edges.

Figure 8: Spandrel wall tilt
