RESEARCH ON DETERIORATION FOR RAKANJI STONE ARCH BRIDGE, HONYABAKEI, OITA, JAPAN

Key words: Stone arch bridge, Deterioration, Non-destructive test, Destructive test, Diagnostic inspection

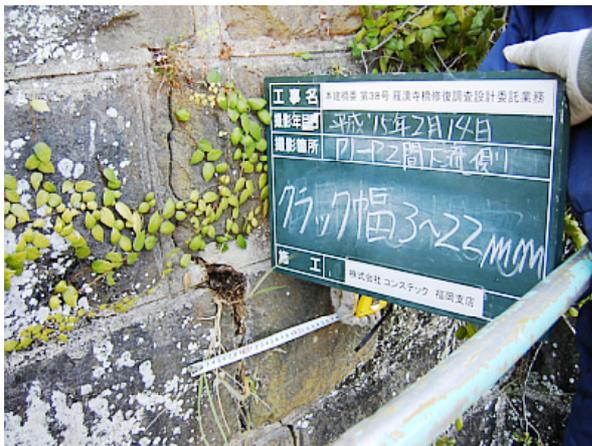
Figure 3: Cracks on Spandrel

As the results of visual inspection and hammering test, the arch stones and spandrel were confirmed to be healthy on the whole. However, vertical cracks with the width of 20~30mm were found on the spandrel near Pier 1 and Pier 2 (Figure 3). Also, there existed some cracks in the crossing direction of the bridge on the asphalt pavement on those piers (Figure 4). The cause of those cracks was estimated to be the creep induced by dead loads of arches working as tensile forces to those areas.

Fortunately, the bad influences of those cracks on the structural integrity of the bridge were not considered to be serious, as those cracks have not reached the arch stones. However, if not repaired, the cracks will extend gradually and influence the stability and function of the bridge.

- Vertical cracks with the width of 20~30mm are found on the spandrel near Pier 1 and Pier 2. The cause of those cracks is estimated to be dead loads of arches working for a long time as tensile forces to those areas and reinforcement is required.

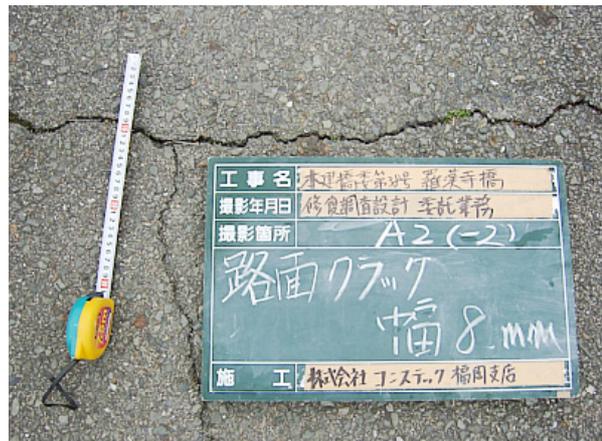
Figure 4: Cracks on Asphalt Pavement

Remarkable cracks with the width of approximately 10mm were discovered on the asphalt pavement near Pier 1 and Pier 2 where tensile forces act. The cause of the cracks was estimated to be the creep induced by the dead load of the arches as well as that of cracks on

the spandrel. And cracks extending in the parallel direction to the rut of road were observed on the asphalt pavement of the bridge near Pier 2 between Pier 2 and Abutment 2. Since gaps were discovered between the concrete slabs and the subbase clay layers generated by the settlement of the subbase clay layers, the cause of those cracks were estimated to be the vibration of the concrete slabs isolated from the subbase clay layer.

The influence of those cracks on the durability of the bridge was not considered to be serious, however, in order to keep the traffic safety, a large-scale repair work of subbase, slabs and asphalt pavement is required.

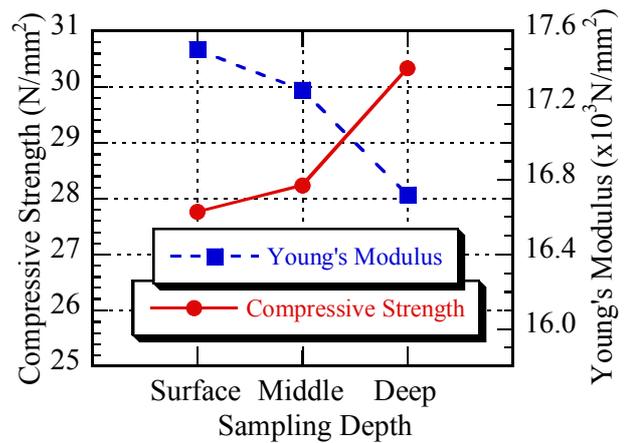
Figure 6: Physical Properties of Stone Cores

In the material tests, average specific gravity of air-dried stones of the spandrel was 1.83, average compressive strength was 28.5 N/mm^2 and average Young's modulus was 17224.2 N/mm^2 . The average compressive strength of the stones of surface part, middle part and deep part were 27.8 N/mm^2 , 28.2 N/mm^2 , and 30.3 N/mm^2 respectively (Figure 6). The average Young's modulus of the stones of surface part, middle part and deep part were 17502.4 N/mm^2 , 17284.4 N/mm^2 , and 16720.7 N/mm^2 respectively (Figure 6). In spite of the tendency that compressive strength of the stones becomes higher as the depth from the surface becomes large, Young's modulus showed the opposite tendency. So, as the results of material tests, it could not be said that the deterioration of the stones of surface part were serious compared to those of deep part.

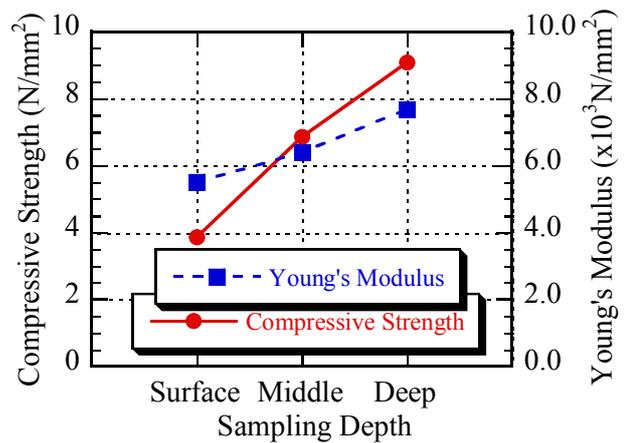
Figure 7: Physical Properties of Mortar Cores

The results of material tests of mortar cores obtained on the spandrel are shown in Figure 7. In the visual inspection of mortar cores, it was confirmed that the mortar had been stuffed densely into the gap of stones, and almost healthy in the deeper part up to the surface. However, since many mortar cores were broken in the surface part when sampled from the bridge and compressive strength and Young's modulus were relatively lower than those of the mortars obtained from deeper parts, the degradation of the mortar was estimated to be progressing from the surface.

- The foundation and surrounding ground are quite sound and no remarkable disorder is discovered.
- The chemical deterioration of the stones is slight except surface, however, the deterioration of joint mortar is serious, and restoring is required.

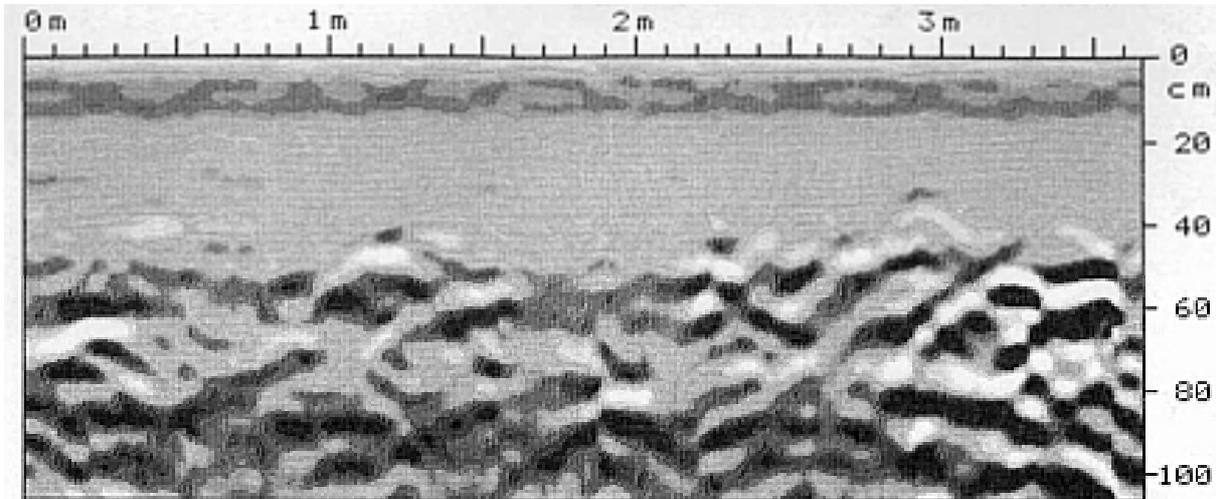
Figure 9: Scanned Image of Spandrel by Electromagnetic Radar

The scanned image of the spandrel by the electromagnetic radar is shown in Figure 9. The thickness of spandrel is estimated to be 45cm by the Figure. However, the measurements obtained from two places are 350mm and 600mm, and it is supposed that the scanned image showed the average thickness of those values. The white, crescent-shaped reflected image seen on the many parts in the Figure indicates the existence of cavities inside.

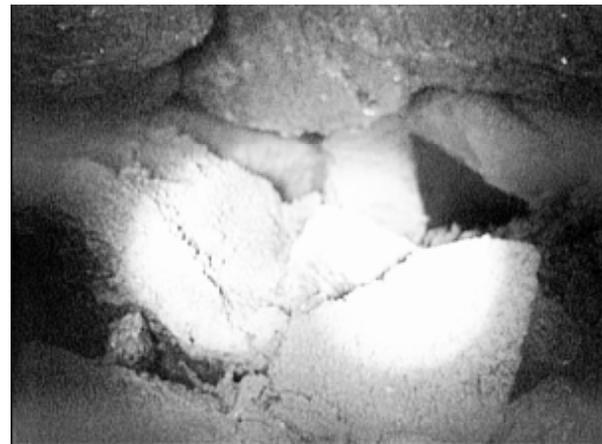
Figure 10: State of Stuffing Stones Observed by Fiberscope

The state of the stuffing stones inspected by the fiberscope is shown in Figure 10. The stuffing stones contain a lot of cavities and in such condition that relatively big-sized stones support each other by point contact, which is unlike gravel. The state of the inside bridge presumed by the result of inspections with the radar, fiberscope and all coring is shown in Figure 11.

- The stuffing stones contain a lot of cavities. Stones with the size of 20~30cm support each other by point contact. Judgment is difficult whether this condition has been made in the construction or generated by long-time spillage of stuffing sand. However, in order to prevent concrete slabs from damaging by the falling of stuffing stones, grouting or other measures are required.

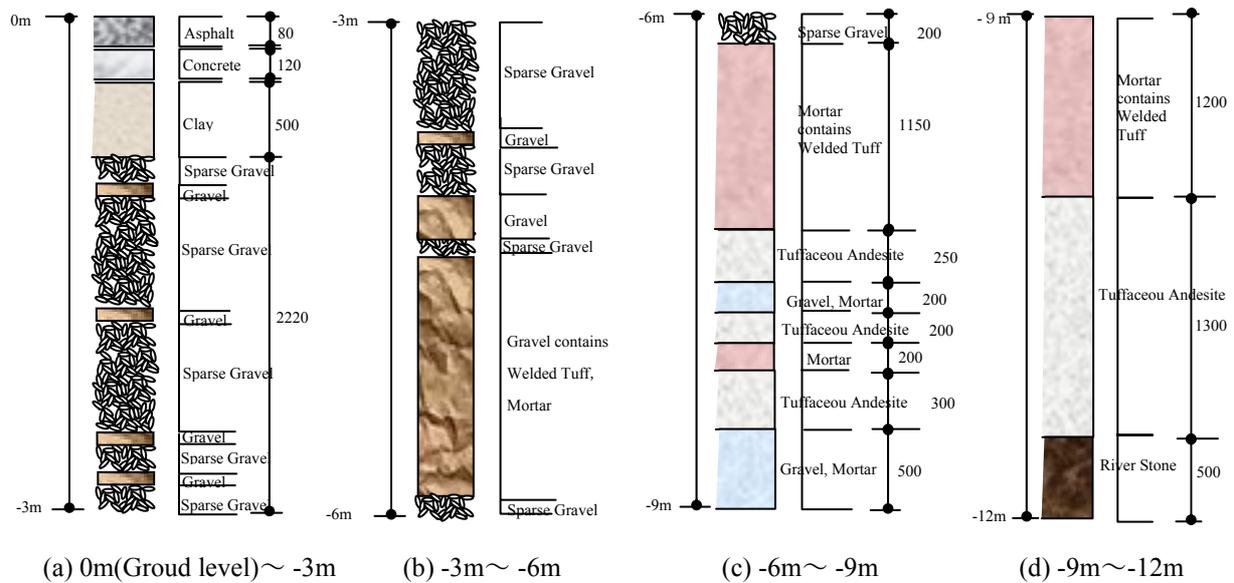
Figure 11: Estimated Inner Structure of the Bridge

Under the subbase clay layer is the gravel layer, where each stone piles up by point contact with a lot of cavities in the gaps. On the other hand, the layer deeper than 5.0m is solid with a few cavities, consisting of welded tuff and tuffaceous andesite with the filling of mortar containing gravel. The result of the inspections leads to the presumption as follows; in the construction of the pier, the stones were piled up in the outer frame with the gravel and mortar filling, and cobblestones of andesite and welded tuff were put inside to form primitive concrete. Above that is the layer consisting of stone debris, river stones, earth and sand, which was considered as “weight” to stabilize the arch by dead load. From the structural viewpoint, if the weight of the stuffing stones is sufficient, the inside cavities seems no problem because the stuffing stones only play a role of “weight” for arch action of the arch stone. However, as independency of the stuffing stones is low, inside cavities would cause lateral pressure on the spandrel if left as they are. And if the bridge should collapse when the stuffing stones inside the bridge supporting each

other by point contact become off balance, it would lower the bearing force of the upper subbase clay layer and concrete slab, and could cause troubles for road traffic. As the result of all coring, it was confirmed that cavities might be developing near the consolidation concrete of foundation of the pier, and the same measures as the stuffing stones' would be necessary.

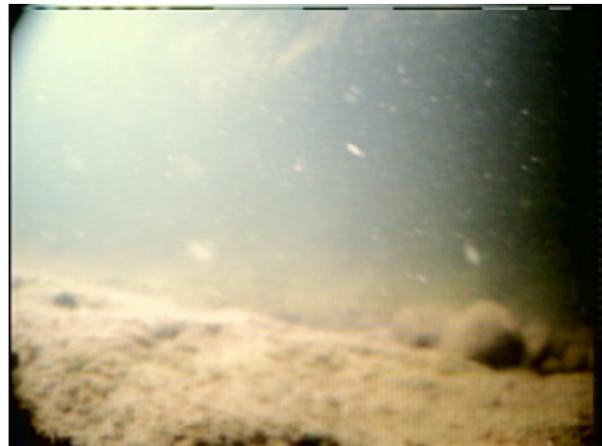
Figure 13: Gap between Pier and River Bed

As the result of the inspections by the submarine video, the pier below the surface of water was sound, and no damage was found (Figure 12). However, some parts of consolidation concrete (the side face on A1 of P1 pier) could not be inspected by the camera, and gaps caused by scouring are likely to be developing between the side and the river-bed (Figure 13).

However, the gaps are slight, and it is possible that they have been existing there since the construction. And the risk that the gaps might have a serious effect on the stability of the bridge is low, although the safety would improve if the consolidation concrete was additionally reinforced.

- No remarkable damage is observed on underwater parts of the piers. However, a gap existing under consolidation concrete is discovered and additional consolidation is required.
