Restoration of the Pont Trençat (Broken Bridge). Barcelona, Spain. (ARCH'04)

Abstract. *In 1811, during the Napoleonic Wars, the "Pont Trençat" bridge suffered the destruction of one of its two arches, the main one. At the beginning of 1999 we were commissioned to develop a bridge restoration project. We first carried out archaeological works and documentary research in order to obtain the information available about the history and the construction sequence of the bridge. Since the bridge was destroyed a long time ago, nobody knows what it really looked like before it collapsed. If we had tried to give the bridge its original shape back we would have had to invent all the information we lacked. Also, people was used to seeing its broken shape. Therefore we proposed to restore it in a way that reflects the contrast between the new work and the existing remains, using a modern material —steel, which is, along with concrete, the most representative structural material of our time— and contemporary constructions techniques. The work began in July 2000 and was divided in three phases: The first part consisted of reinforcing the old remains, made of stone, as well as building the new f

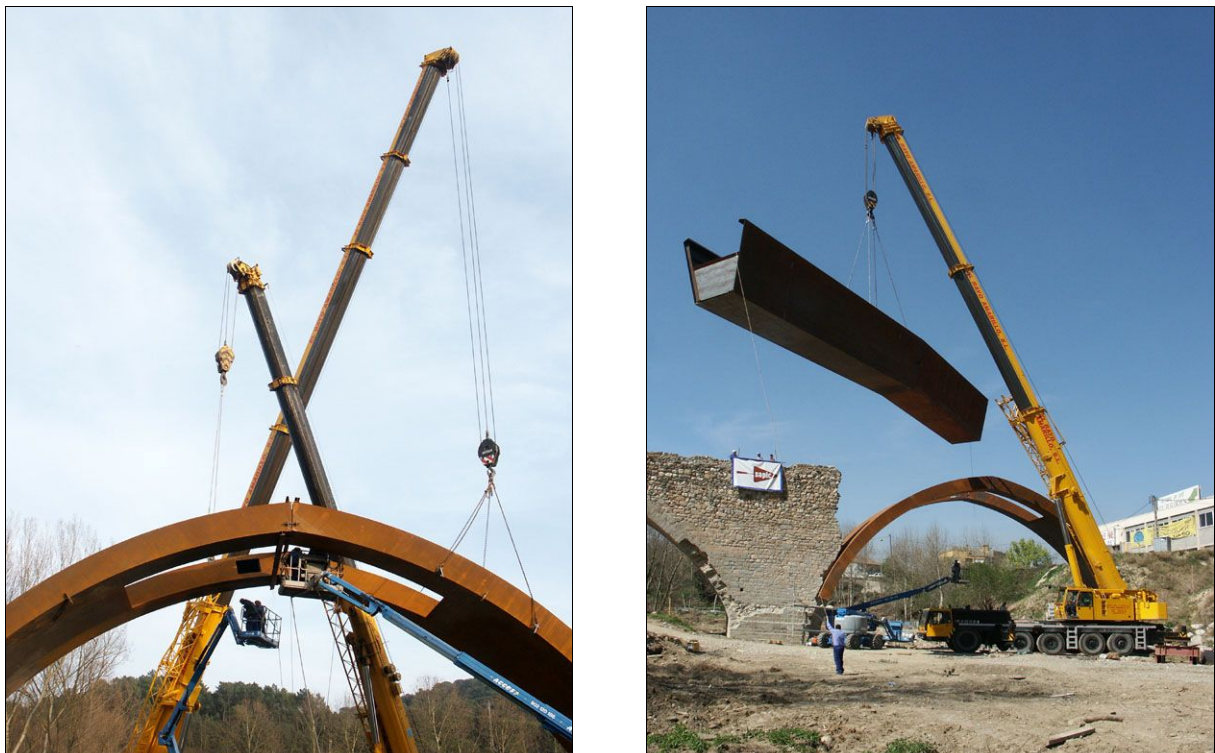
Figure 8 – Erection of the arch and lifting of the deck

In the second phase the abutments of the deck were made; one on the existing remains, and the other one on the right bank. The steel structure was constructed in Gava, in the Tamansa's workshop, seventy kilometres away from the work side, and was transported in five pieces; three for the deck and two for the arch. We first lifted the two parts of the arch which were welded to each other in the crown. For the deck, before it was erected, we welded two of its parts and then we installed it in two pieces welded to each other on site.
