THE “GRADELLE” BRIDGE ON ST. MASSIMO CHANNEL IN PADOVA

Giulio Mirabella Roberti^{*}, Elisa V. Temporin[†]

Key words: Arch Bridge, Brick Masonry, barrel vault, city walls, Renaissance

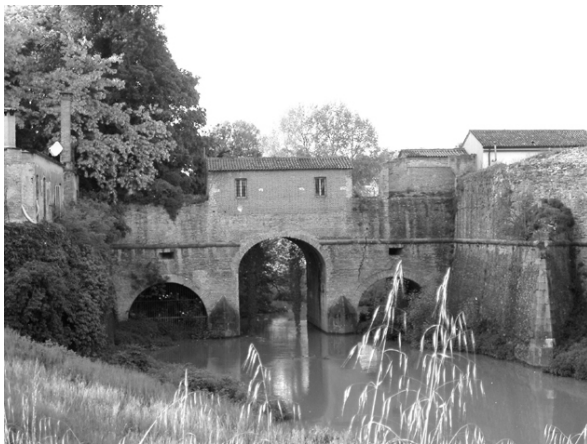
It is made by three barrel vaults of equal span, the central one of higher rise; two small buildings lean against the South parapet. It appears sober, rigorous and solid, but elegant in its simplicity. The construction is made of solid brick masonry and *trachite euganea* stone, without any covering. It is situated near an arterial road, but it is surrounded by the nature: the St. Massimo channel still flows under two of its vaults and two green areas surround it both at East and at West. The zone, one of the most evocative and characteristic of the town, is waiting for years for the realization of the “Parco delle acque e delle mura”, the project of the city council which aims to connect all the green areas that has survived near the renaissance city walls and the water ways that cross or surround the town.

Figure 1: South view of the bridge

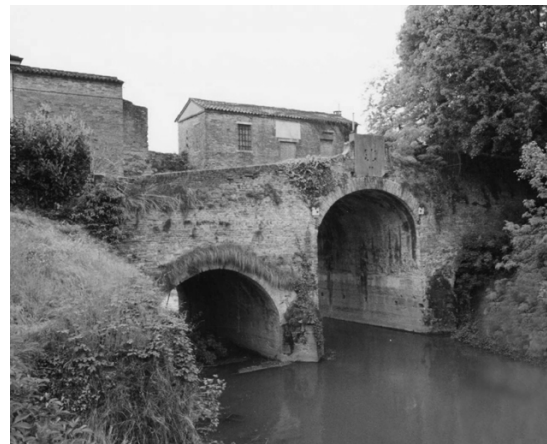
Figure 2: North view of the bridge

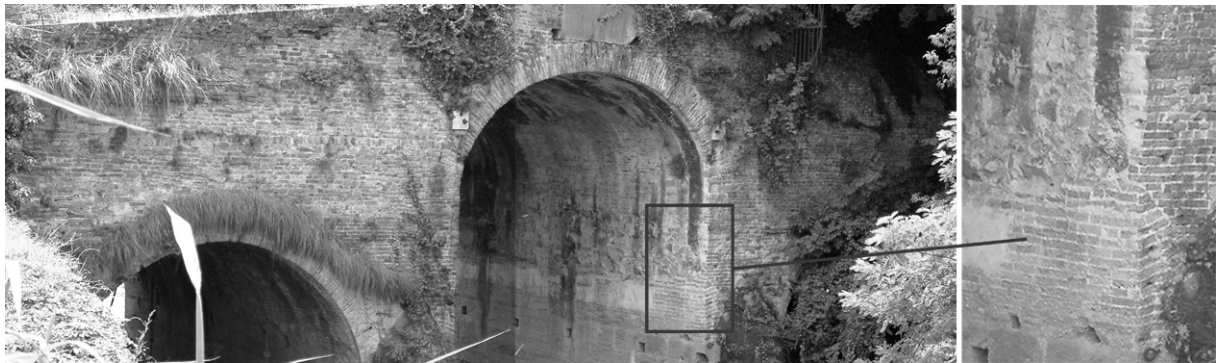
Figure 7: The central barrel with a detail of the abutment of the ancient vault

By the '80s, the ex-tollhouse was occasionally used as classroom by a cultural association, for showing to children the bread making, but by now the bridge lives only in the sporadic spring visits organized by cultural associations to re-discover the past. It is now in a state of semi-disrepair. Some openings are walled up, big cracks appeared; lime deposits obstructed the lateral vaults and the walls are colonized by the ivy and other vegetation hanging on the water of the central arch.
