RESEARCH ON DETERIORATION FOR RAKANJI STONE ARCH BRIDGE, HONYABAKEI, OITA, JAPAN

Key words: Stone arch bridge, Deterioration, Non-destructive test, Destructive test, Diagnostic inspection

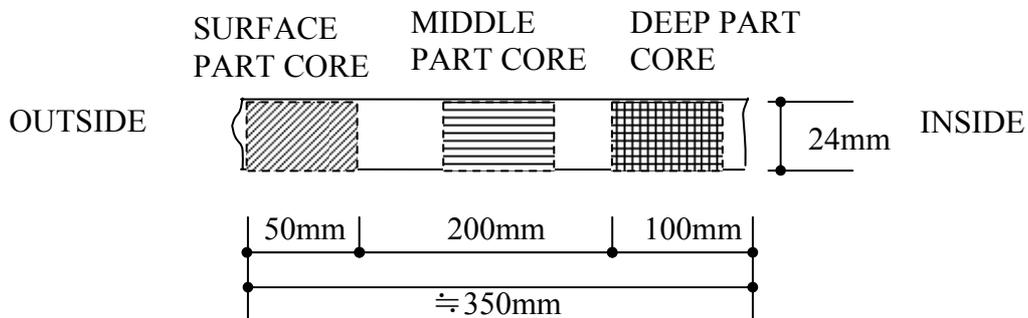
Figure 5: Small Core Tested

In order to evaluate the conditions of materials of each depth separately, small cores of 350mm length obtained from the spandrel were cut into three pieces at 0mm~50mm (surface part), 50mm~250mm (middle part) and 250~350mm (deep part) from the surface (Figure 5) and compressive strength and Young's modulus were measured. Total numbers of small cores of mortar, spandrel and handrail stones are four, four and two, respectively. Also, two cores were penetrated to the rear side of the spandrel in order to measure the width of the stones.

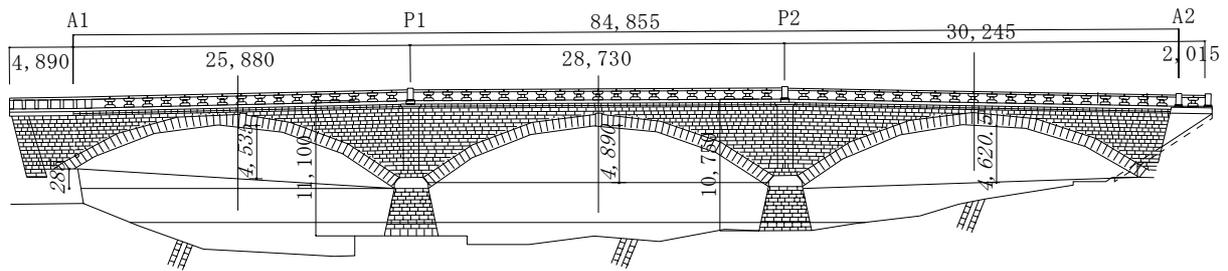
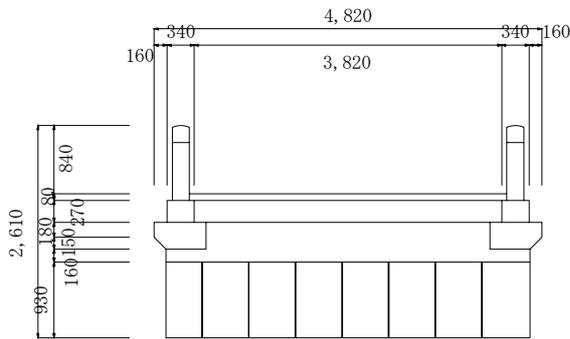
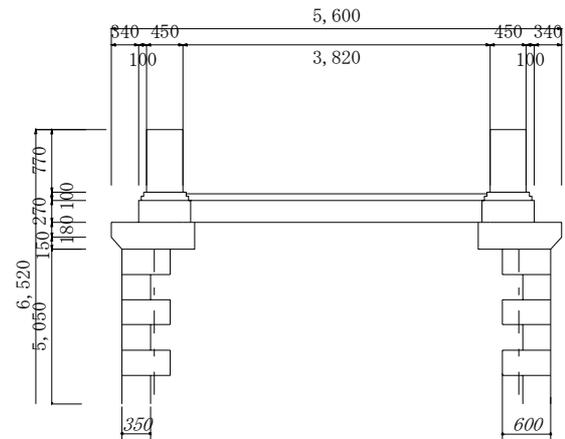
Figure 8: Results of Measure (unit: mm)

The results of measure of the bridge and thickness of stones are shown in Figure 8. The thicknesses of the stones of the spandrel were estimated from the results of Rader scanning (Figure 9), small core sampling, and pattern of the mortar joint. Since the original plan of the bridge did not remain, reviewing of the quantity of deformation was impossible. However, these results can be a valuable material for the health monitoring from now on.
